PIPE RESTORATION SOLUTIONS

BOCA CIEGA CONDO #16 CAMERA INSPECTION

Boca Ciega Condo #16
403-645 Boca Ciega Point Blvd
St. Petersburg, FL 33708

Boca Ciega Condo #16 Sanitary Stack Inspection

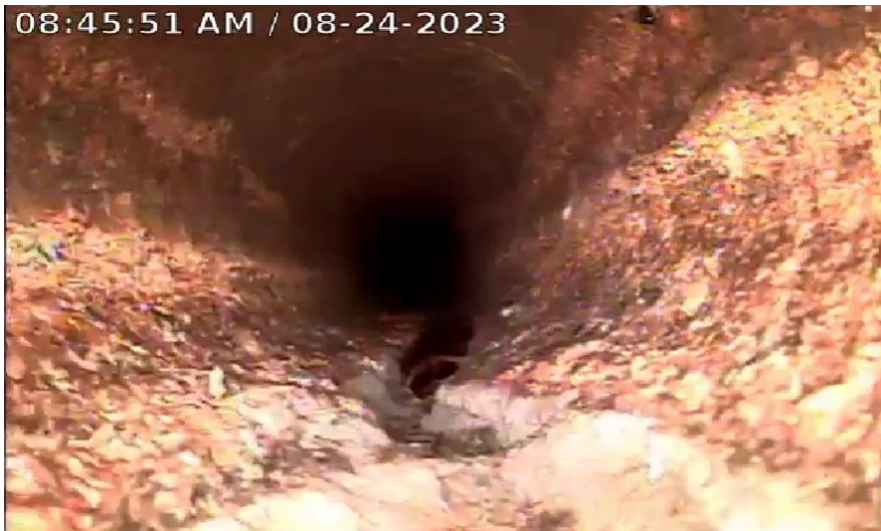
08:45:51 AM / 08-24-2023

This is the kitchen lateral for Unit 403. This line is cracked. PRS recommends hydro jet cleaning to open the pipe back up to the original diameter and CIPP lining to seal the crack.

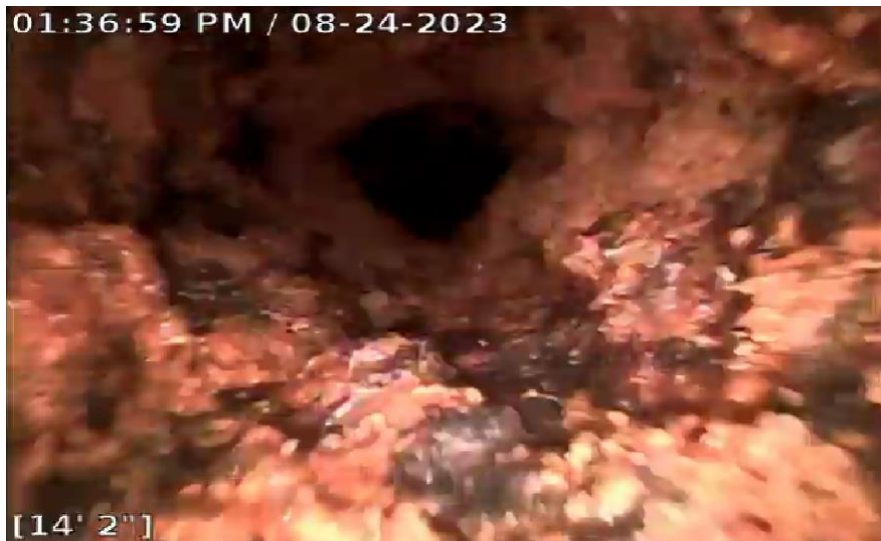
01:36:59 PM / 08-24-2023

This is the kitchen stack for Unit 463. This line has heavy build up. PRS recommends hydro cleaning to open the pipe back up to the original diameter.

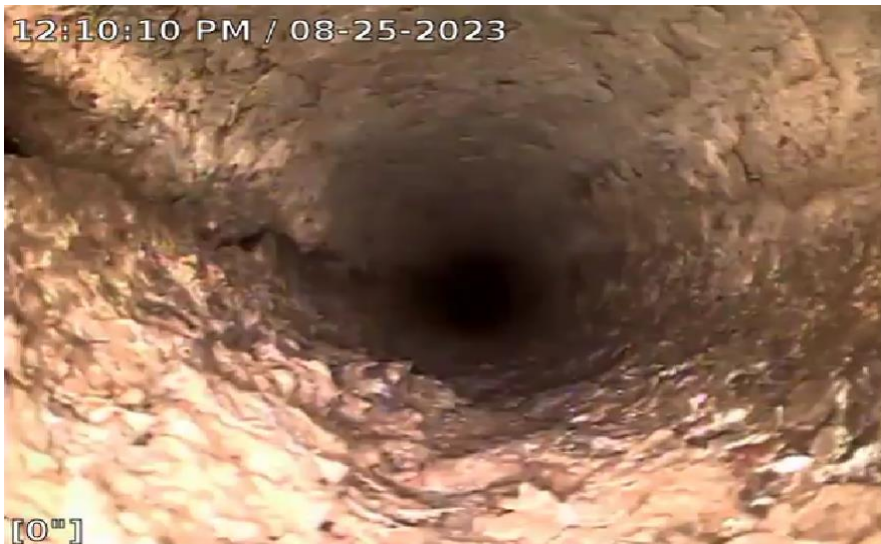
12:10:10 PM / 08-25-2023

This is the laundry lateral for Unit 517. This line is cracked. PRS recommends hydro jet cleaning to open the pipe back up to the original diameter and CIPP lining to seal the crack.
