Uniform Mitigation Verification Inspection Form

Inspection Date: 3/29/2019		
Owner Information		
Owner Name: Boca Ciega Point Condo #16		Contact Person:
Address: 565n-587n Boca Ciega Point Blvd		Home Phone: (727) 398-1270
City: St. Petersburg	Zip: 33708	Work Phone:
County: Pinellas		Cell Phone:
Insurance Company:		Policy #:
Year of Home: 1973	# of Stories: 1	Email: Bocaciegapoint5150@tampabay.rr.com

Elevation Photos

565n-587n Boca Ciega Point Blvd

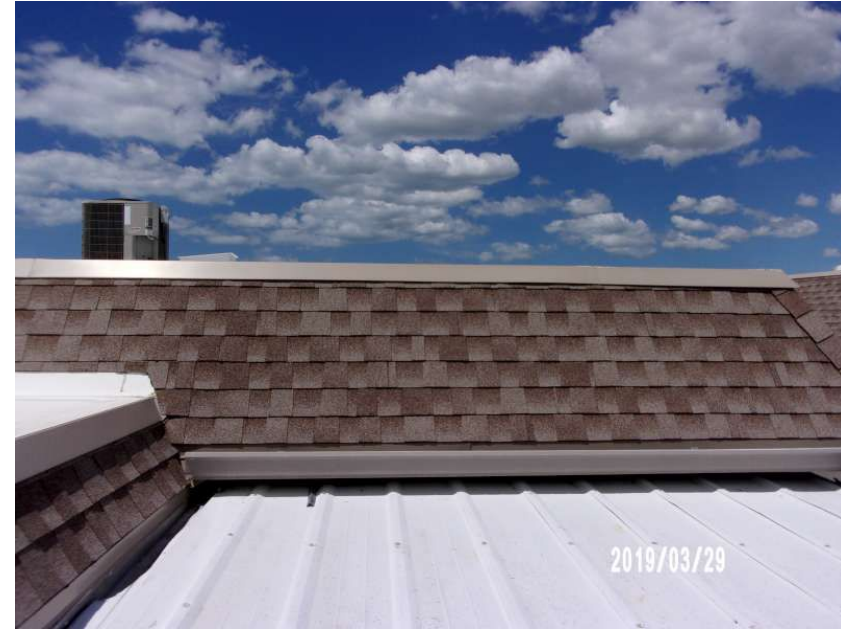
Architectural/Dimensional Shingle Roof Covering

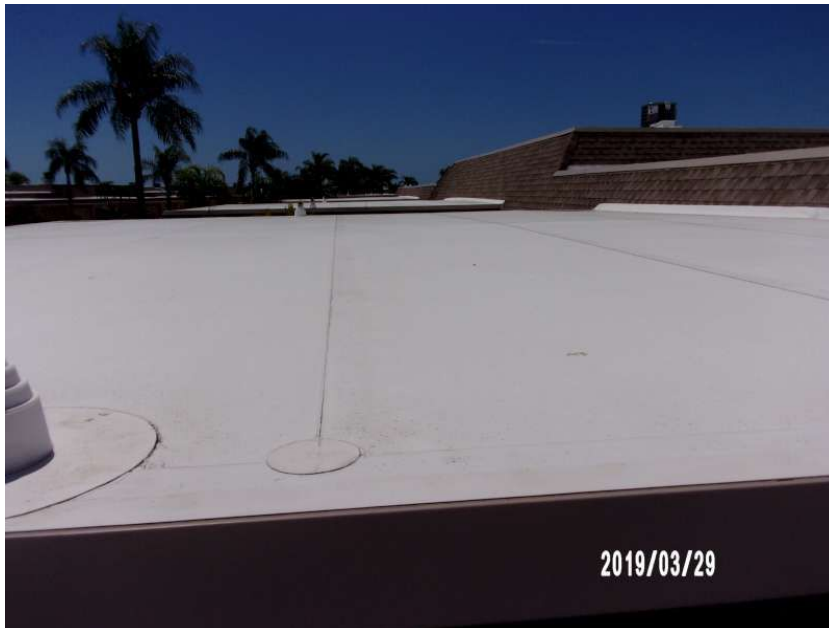
Membrane Roof Covering

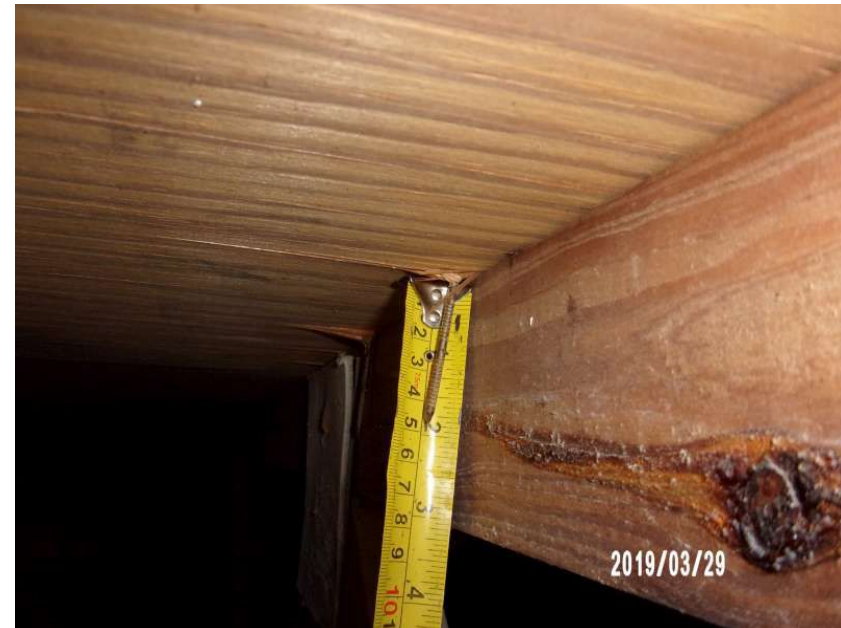
8d Nails or Greater in Size

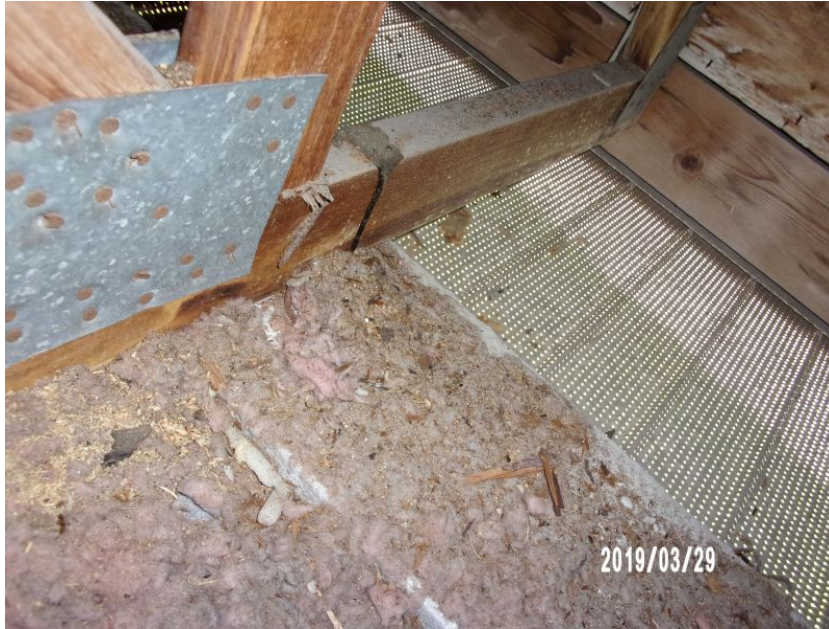
Metal Connector with 2 Nails on the Front Side & 0 Nails on the Opposing Side

Roof-to-Wall Attachment Our report indicates that the existing roof-to-wall attachment(s) do not meet the requirements on the Uniform Mitigation Verification Inspection form for Single Wrap Straps. This definition requires at least two nails on the front side and at least one on the other of every strap in the attic, on every truss or rafter. As it is often difficult to access every truss or rafter, the ideal time to upgrade this feature is when the roof deck is being replaced. In some circumstances, this work can be done on its own; consult a professional for details. Retrofits to existing roof to wall connections should be permitted with the local building department, and installations should follow the manufacturer's guidelines.

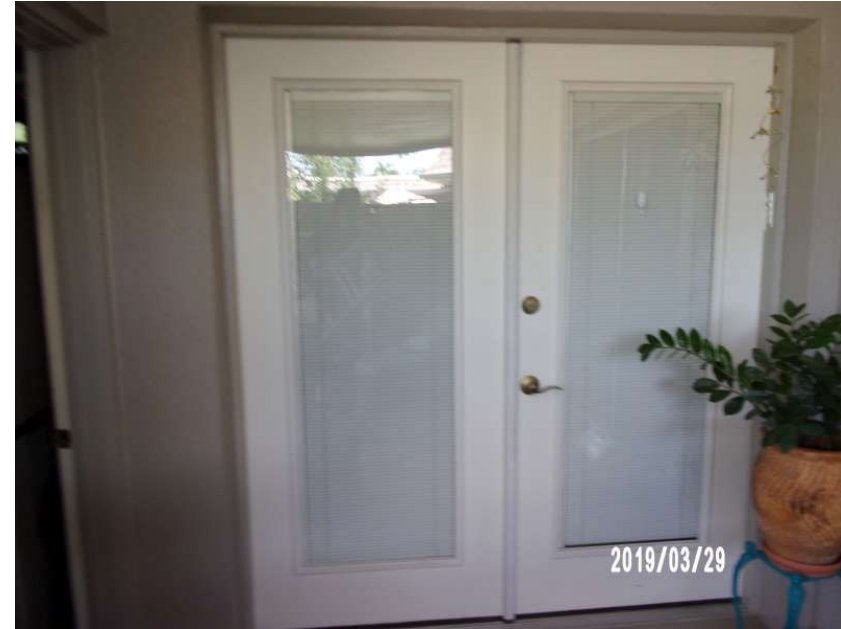
Unprotected Glazed Entry Door

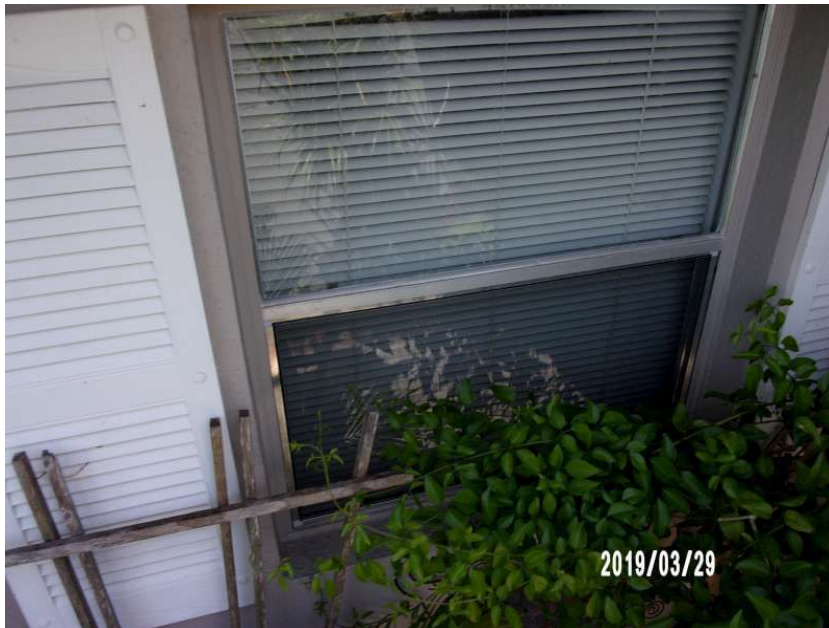
Unprotected Window

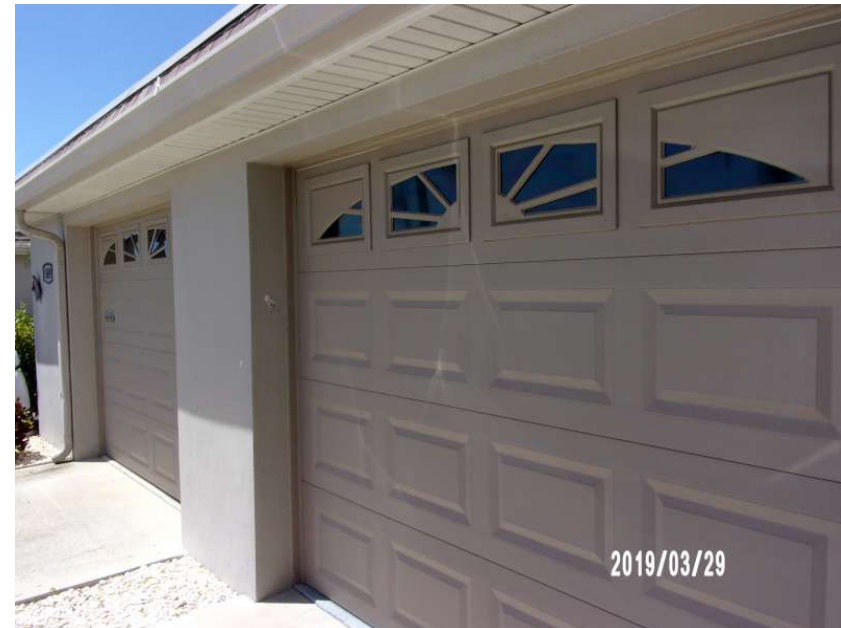
Unprotected Glazed Garage Door
