Uniform Mitigation Verification Inspection Form

Inspection Date: 3/29/2019		
Owner Information		
Owner Name: Boca Ciega Point Condo #16		Contact Person:
Address: 403n-493n Boca Ciega Point Blvd		Home Phone: (727) 398-1270
City: St. Petersburg	Zip: 33708	Work Phone:
County: Pinellas		Cell Phone:
Insurance Company:		Policy #:
Year of Home: 1973	# of Stories: 1	Email: Bocaciegapoint5150@tampabay.rr.com

403n-493n Boca Ciega Point Blvd

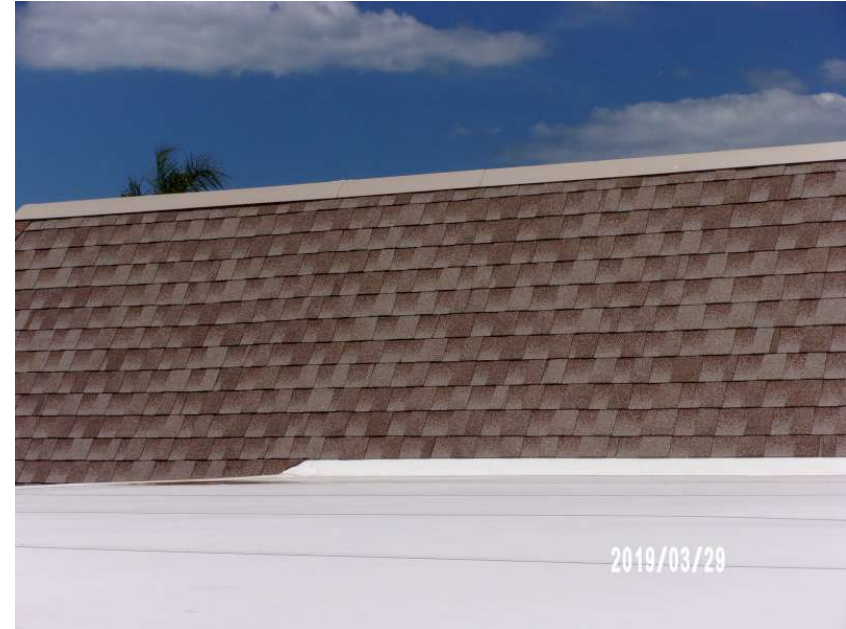
Architectural/Dimensional Shingle Roof Covering

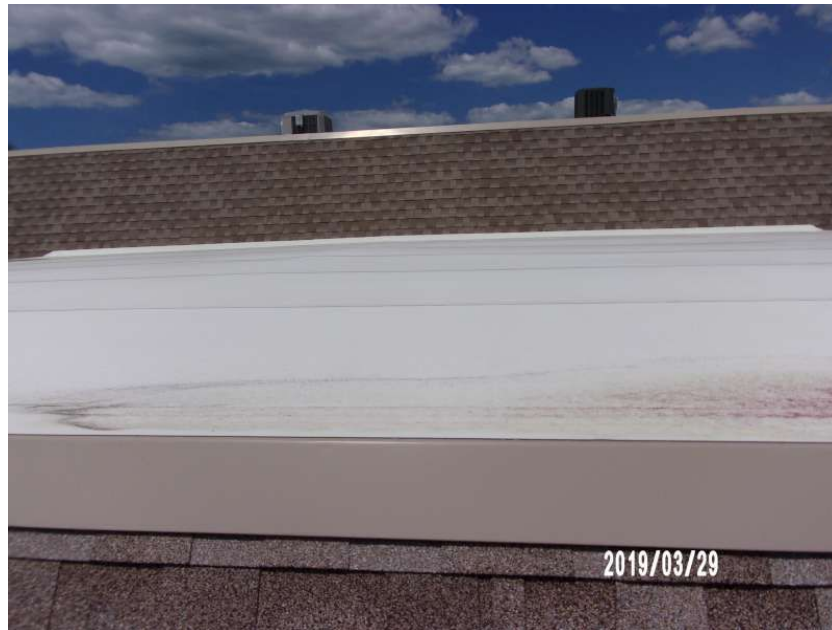
Membrane Roof Covering

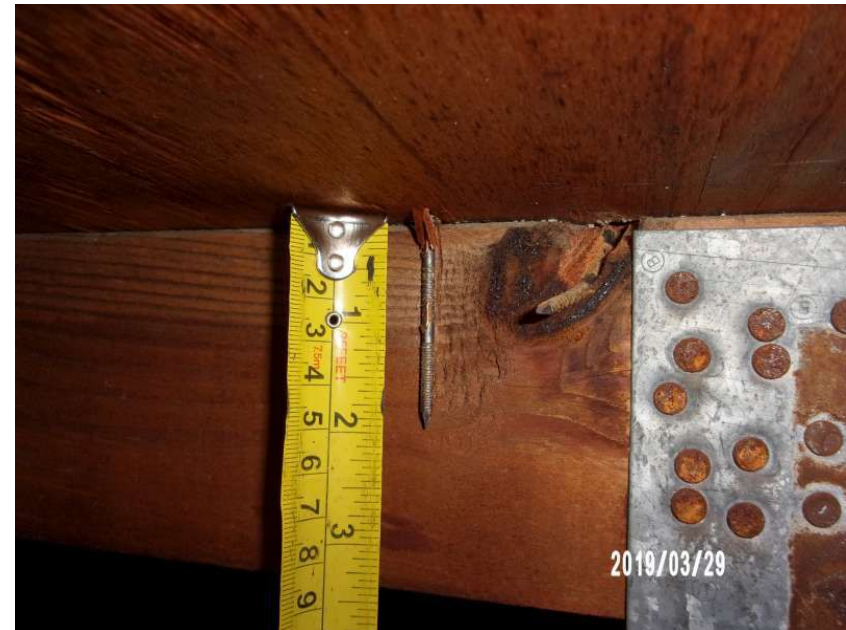
8d Nails or Greater in Size

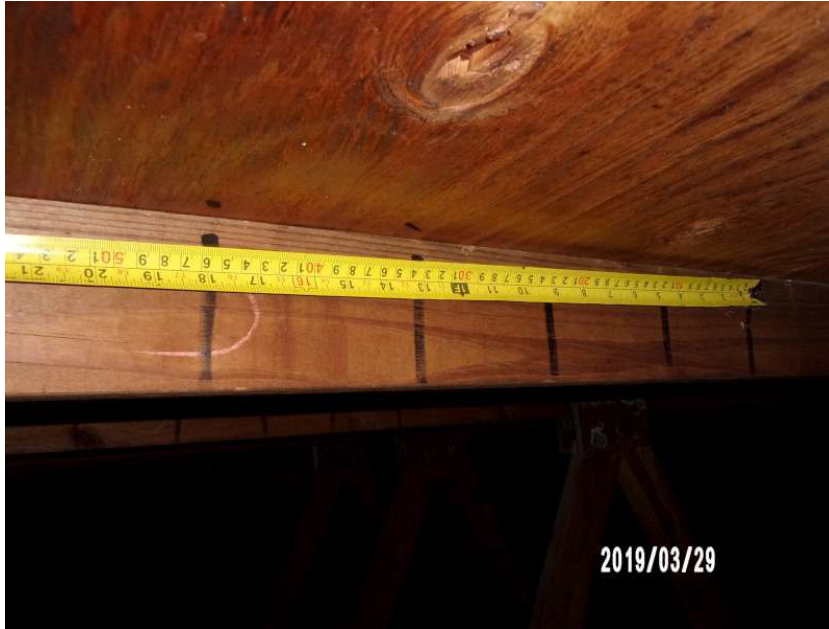
8d Nails or Greater in Size Spaced 6" Along the Edge

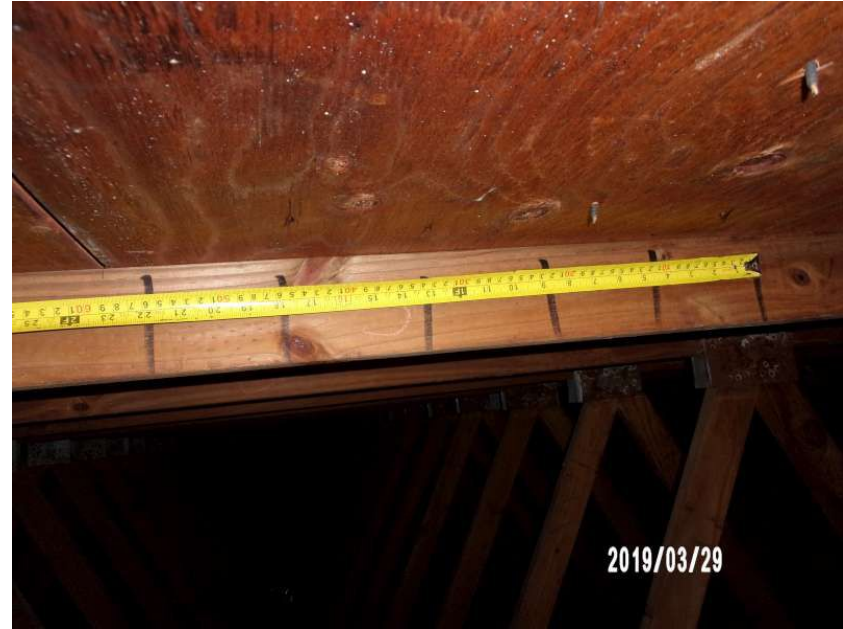
8d Nails or Greater in Size Spaced 6" in the Field

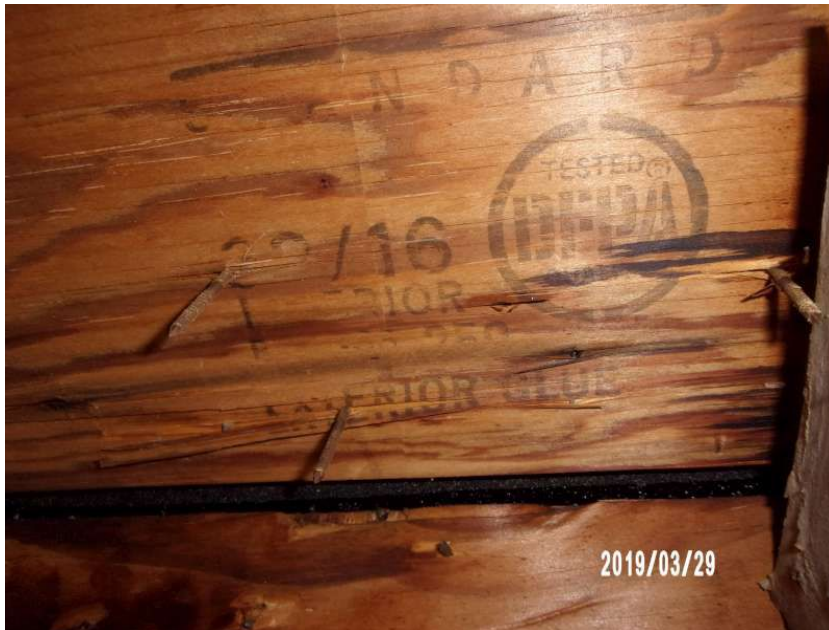
1/2" Deck Thickness Confirmed

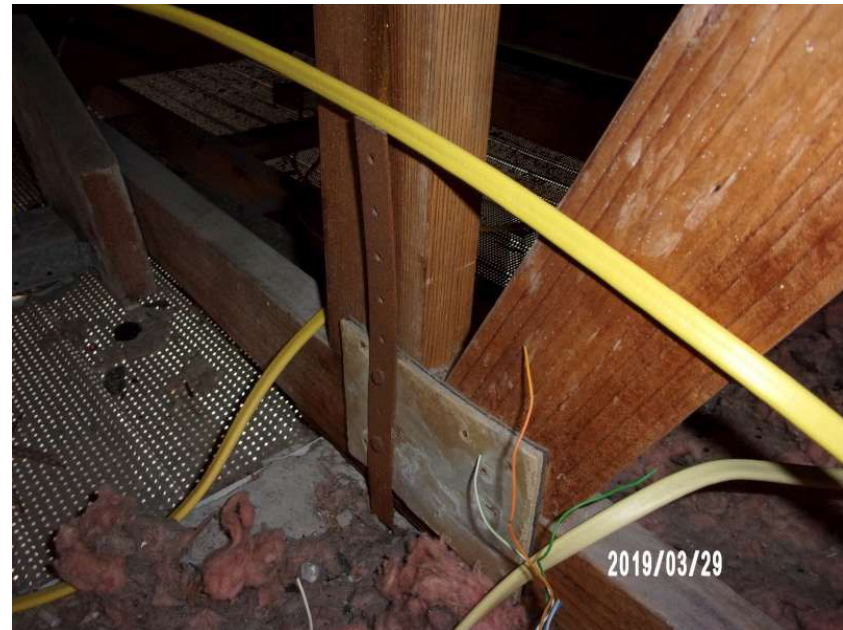
Metal Connector with 2 Nails on the Front Side & 0 Nails on the Opposing Side

Roof-to-Wall Attachment Our report indicates that the existing roof-to-wall attachment(s) do not meet the requirements on the Uniform Mitigation Verification Inspection form for Single Wrap Straps. This definition requires at least two nails on the front side and at least one on the other of every strap in the attic, on every truss or rafter. As it is often difficult to access every truss or rafter, the ideal time to upgrade this feature is when the roof deck is being replaced. In some circumstances, this work can be done on its own; consult a professional for details. Retrofits to existing roof to wall connections should be permitted with the local building department, and installations should follow the manufacturer's guidelines.

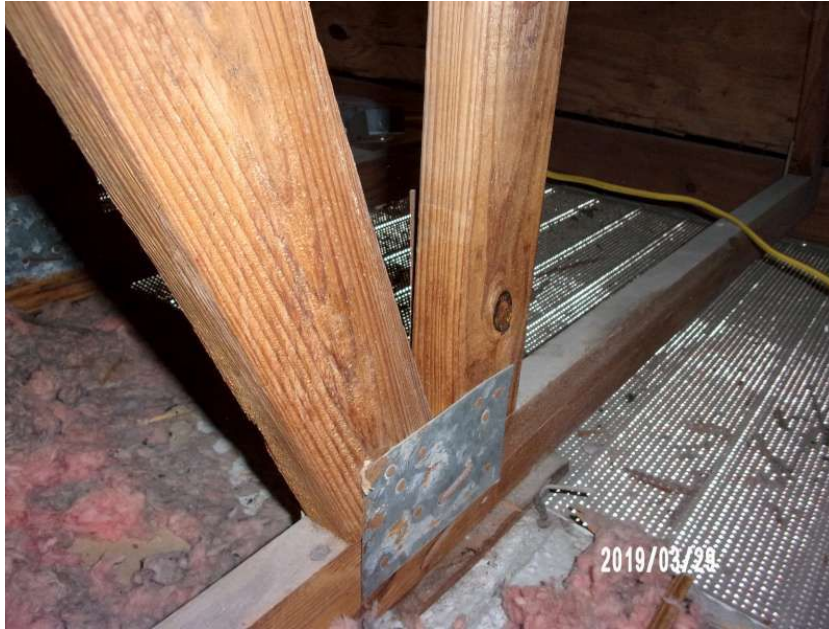
Metal Connector with 2 Nails on the Front Side & 0 Nails on the Opposing Side

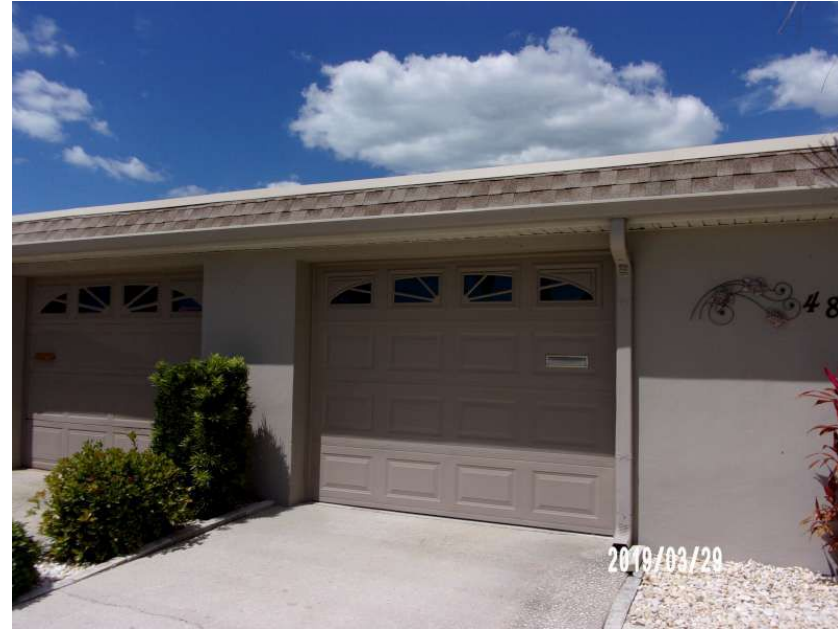
Unprotected Glazed Garage Door

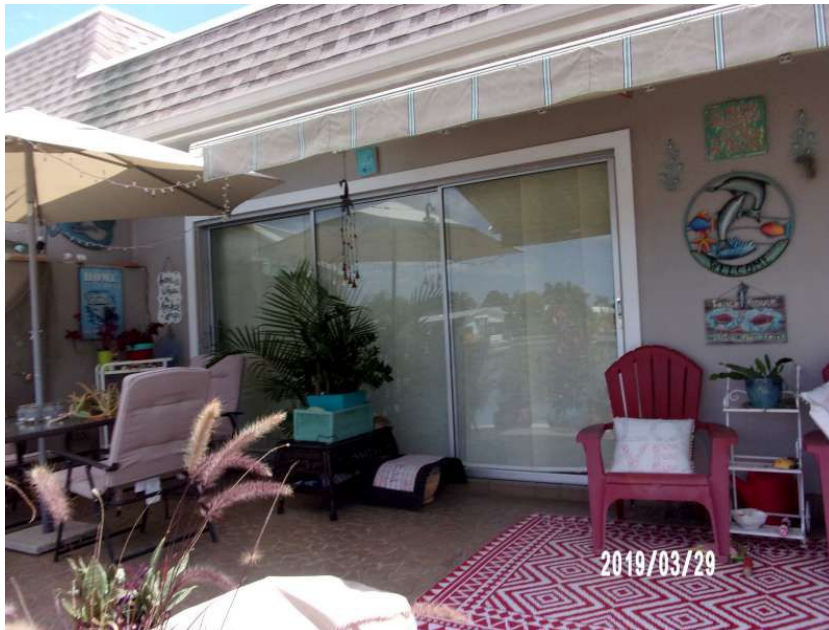
Unprotected Glazed Entry Door

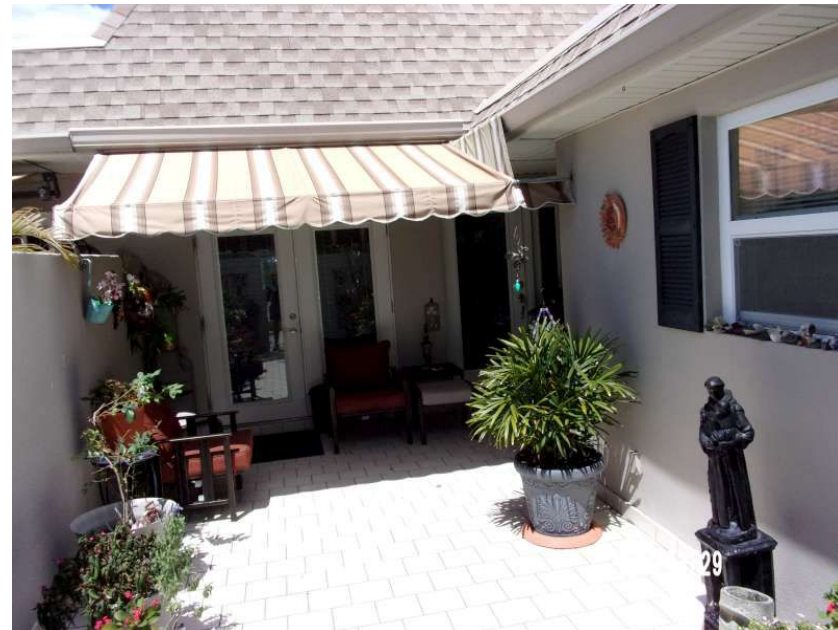
Unprotected Glazed Entry Door/Window
