SEWER CAMERA INSPECTION
Boca Ciega Condo #16

Boca Ciega Condo #16 403-645 Boca Ciega Point Blvd St. Petersburg, FL 33708

Date: 9/6/2023

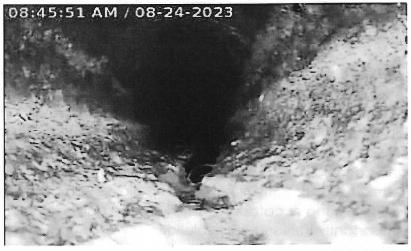
This is the kitchen lateral for Unit 403. This line is cracked. PRS recommends hydro jet cleaning to open the pipe back up to the original diameter and CIPP lining to seal the crack.

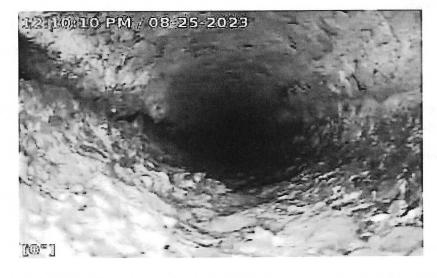
This is the laundry lateral for Unit 517. This line is cracked. PRS recommends hydro jet cleaning to open the pipe back up to the original diameter and CIPP lining to seal the crack.
